## 9.3: Repairing the HST

### Repairing the HST

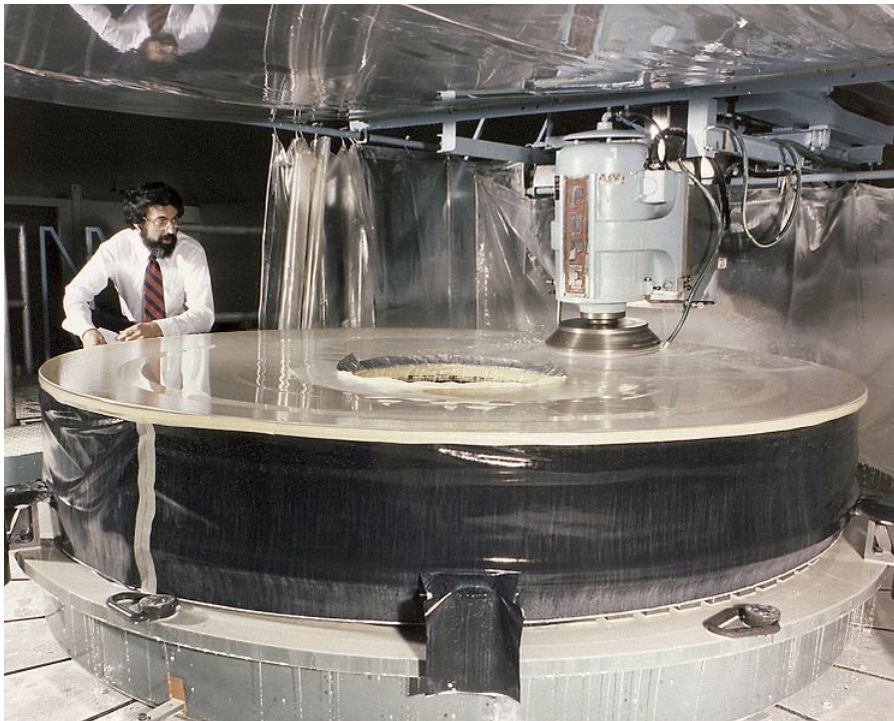
Hubble's primary mirror during fabrication. [ " Hubble mirror polishing " by NASA, in the [Public Domain](#) ]

As astronomers checked out their new telescope after launch, it became painfully obvious that something was wrong with the telescope. It was as if the HST was nearsighted; the telescope was not getting a good focus. Stars and galaxies looked fuzzy, something one did not want to see from a multi-billion-dollar telescope. After an investigation, it was found that the HST's primary mirror was shaped to the wrong curve, producing out of focus images.

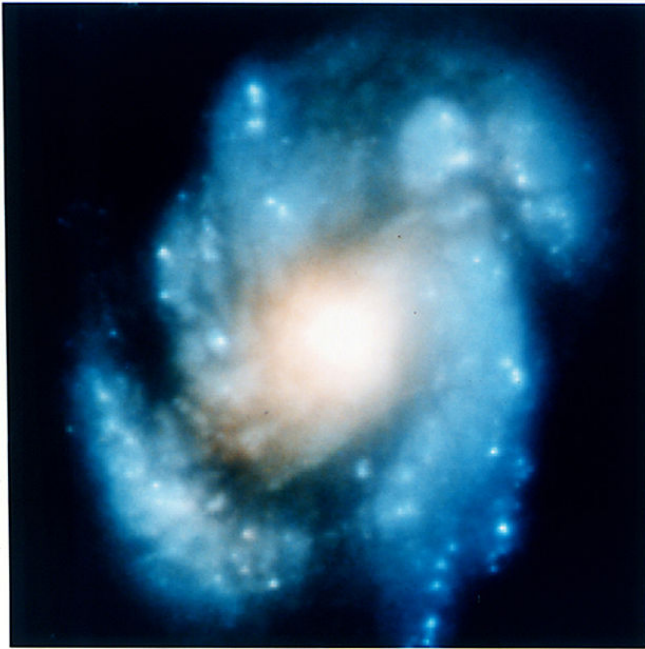
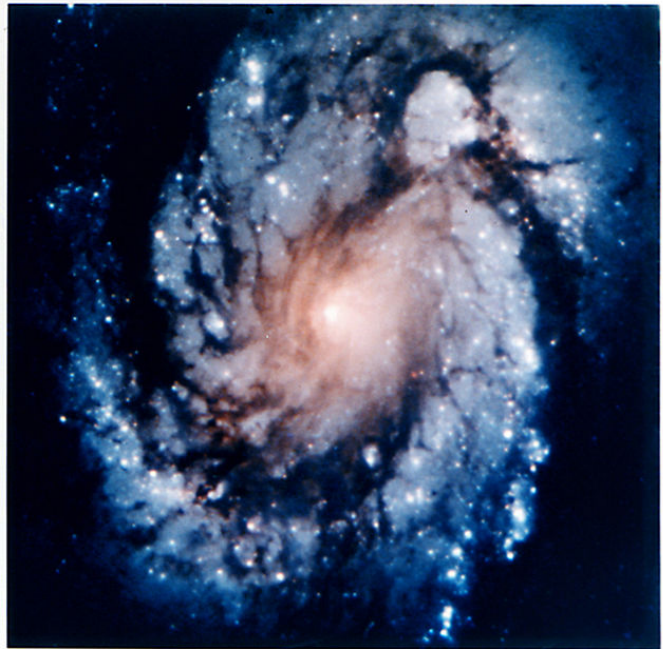
Wide Field Planetary Camera 1

Hubble without corrective optics (left) — and with corrective optics. After determining the primary mirror was flawed, a corrective optical system — glasses — was designed, built, and flown aboard the Space Shuttle to the Hubble Space Telescope, where it was installed. [” Hubble Images ” by NASA, in the [Public Domain](#) ]

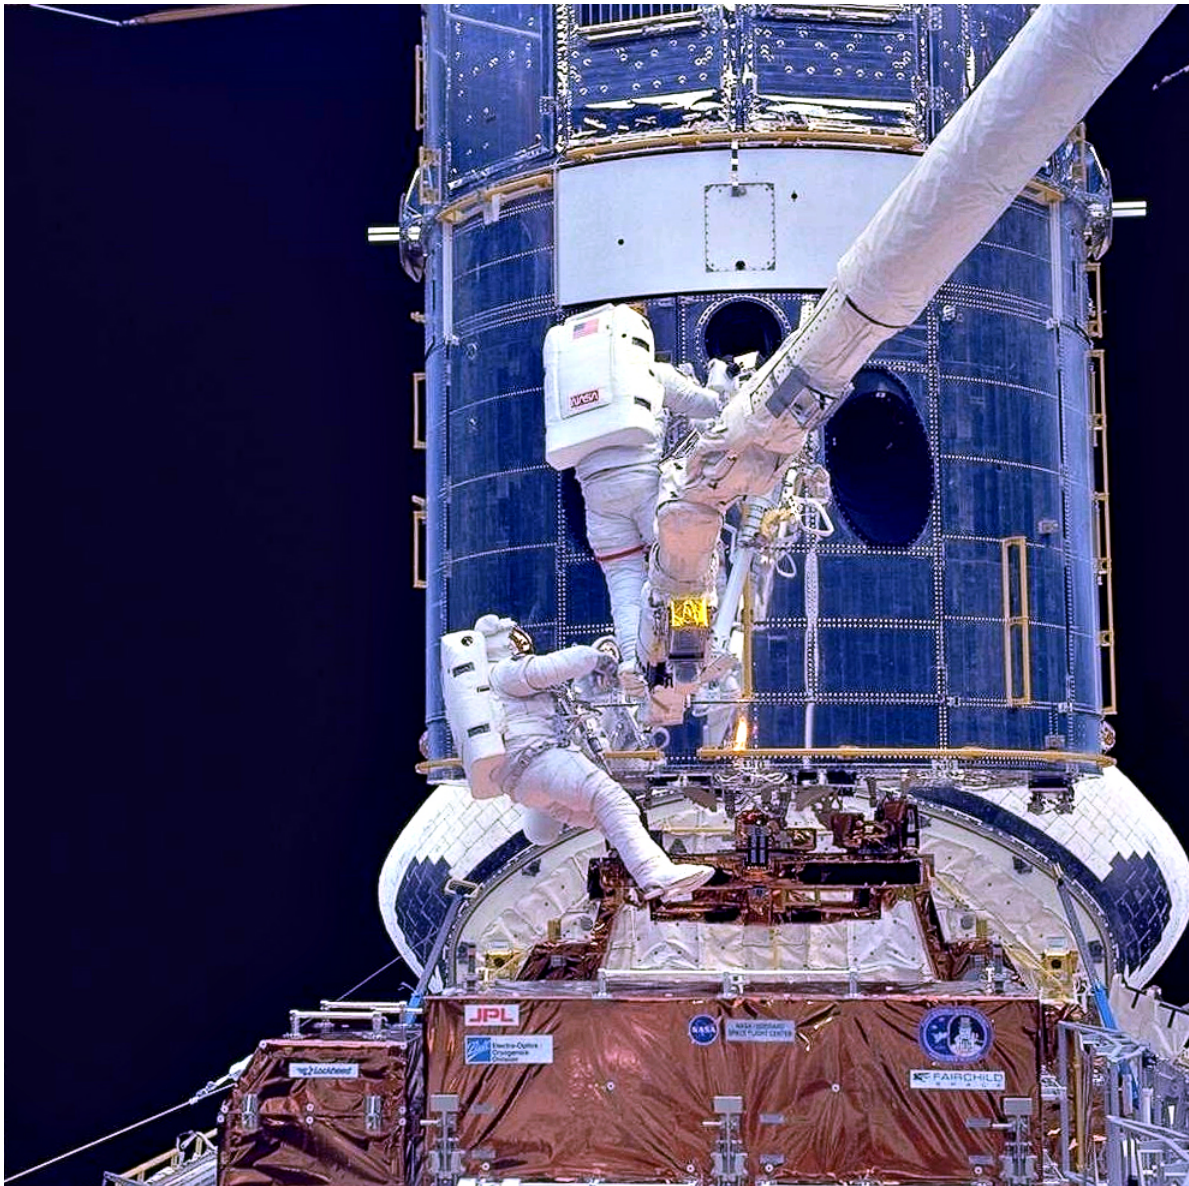
Hubble's first servicing mission was to install the corrective optics package, along with other repairs and upgraded. The HST was captured by the Shuttle's robotic arm and then placed on an HST-specific base in the Shuttle's Cargo Bay. Astronauts could then take a spacewalk to effect repairs. [” Upgrading Hubble during SM1 ” by NASA, in the [Public Domain](#) ]
